Leach Pottery St. Ives

Heritage and Repair Statement

Phase 2 Planning and Listed
Building Consent Application

September 2023

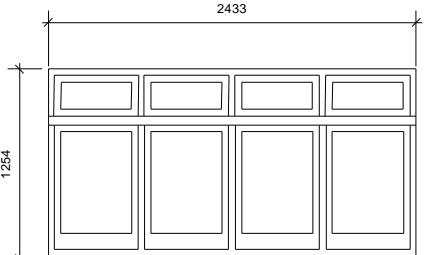
<p>External Elevation</p>

4.7	4	Pottery (clay room)	North facing window and west facing window [W.72 and W.73]	The windows require general refurbishment	Rub down windows and redecorate. Retain ironmongery.	Repair	Medium	Risk of further degradation to the window, and damage to internal finishes

<p>Window reference: W.72 Room: G-74 Clay Room Approximate age of fabric: Believed to have been replaced as details do not match other sash windows. Opening: Three over three sash window, with lower vertically opening sash</p> <p>Description of current condition: Window is in need of refurbishment, sill is in disrepair. Proposed works: Window to be repaired, timber splice repair needed to the sill and bottom rail, rub down timber and re-oil. Redecorate window. Retain and recondition ironmongery.</p>
