**BAT AND BARN OWL ASSESSMENT**

**LEACH POTTERY**

**HIGHER STENNACK**

**ST. IVES**

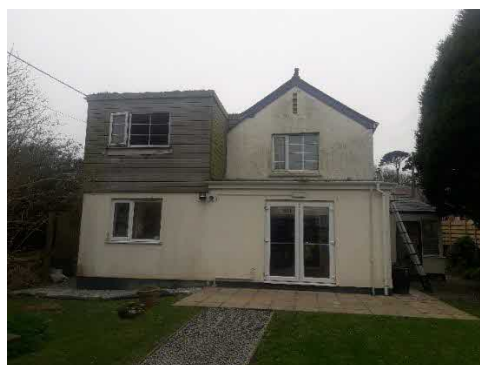
Figure 1. Cottage.

The cottage, which is proposed to be demolished is currently in use as an office and accommodation. This building is two storied and constructed from local stone with cavity walled block -built extensions on the western and eastern elevations and a timber framed extension on the southern elevation. The roof of the building is covered with slate which is underlined with a breathable membrane. There are slates verges on the western and eastern gables of the building. The roof void of this building was entered and searched for evidence of use by bats followed by a search of the exterior. A telescopic ladder was used to gain access to the slate verges and to view any gaps or crevices within the building. No evidence of use by bats was noted.

Although no current evidence of roosting bats was found it cannot be assumed that bats are not present when works commence. Care should, therefore, be taken during the work as bats could roost unseen deep within crevices in the structures. If any bats are discovered during the work, they must not be handled: works must stop immediately, and advice sought from CEC (tel 01872 245510).

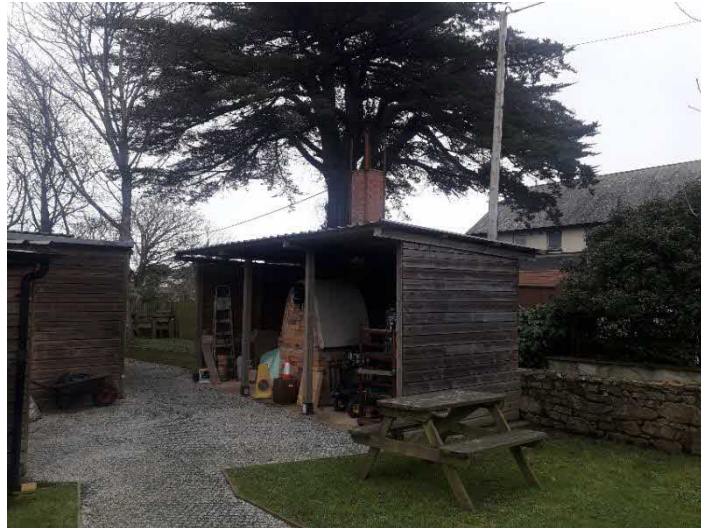
Figure 2. Open fronted store/kiln

This is a wooden built structure which is in use as a store and has a centrally located pottery kiln. The wall of the building is constructed from timber and the roof is covered with corrugated metal sheeting. The building offers limited opportunities for day roosting bats but does offer potential as a night/feeding roost. A careful search was undertaken, including the floor, stored items and viewing the gaps between the bricks used to form the kiln. No evidence of use by bats was noted.

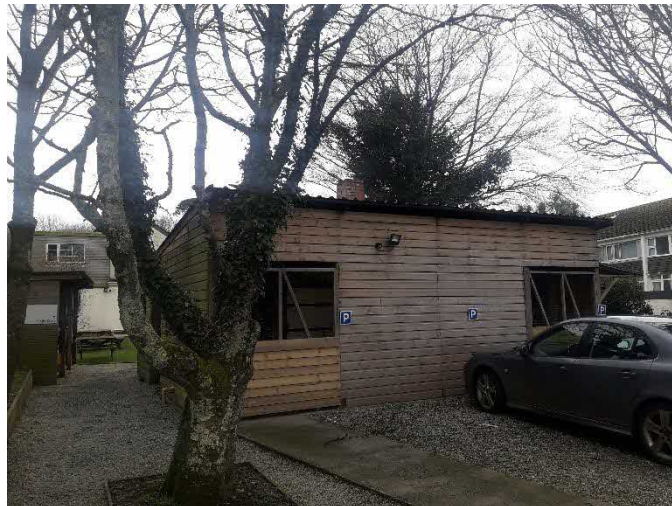
Figure 3. Kiln room and store

This is a single storied wooden structure which is covered with part corrugated metal sheeting and fibre glass. The building is in use for kilns and as storage, as such it is in regular, daily use. Apart from the storage area of the building, the interior is open and light and offers low potential for use by day roosting bats but there are areas open and accessible to night/feeding bats. A search of the interior and exterior was undertaken, including the floors, walls and features considered suitable for use by bats. No evidence of use was noted.

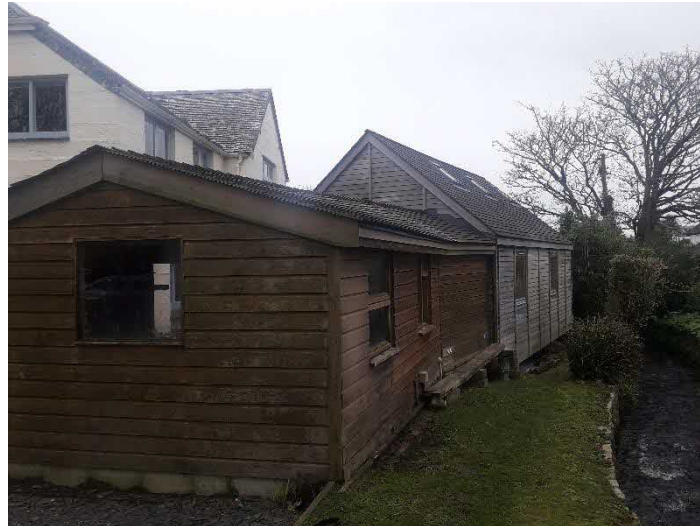
Figure 4. Pottery, Store and part museum

This building is single storied and is clad with timber and has a cedar shingle roof. The building is in use as a pottery, store and part of the museum. As such the interior of the building is in regular, daily use and offers low potential for use by day roosting bats. This assessment concentrated on external features bats could use to roost within and as there are no roof voids, gain access into gaps beneath the shingle roof. The building is tightly sealed with no visible access suitable for use by roosting bats.

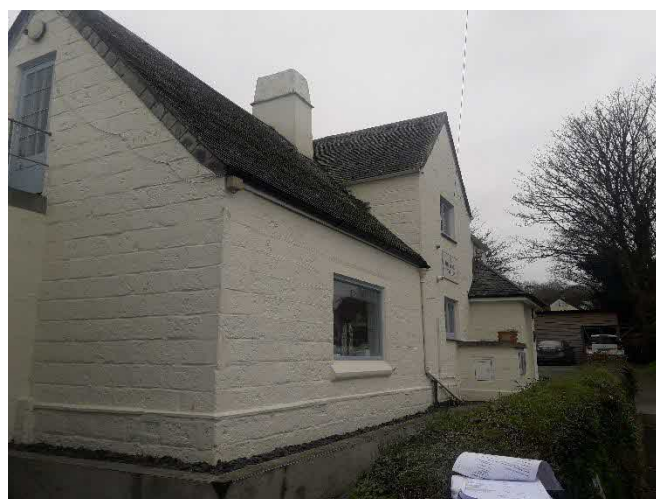
Figure 5. Shop and offices

This is a two storied building built from local stone and cavity walled concrete block with a slate roof. No works are currently proposed to be undertaken on this building and as the building is in regular use, a brief inspection of exterior features offering potential for use by bats was undertaken. The roof of the building has many areas and features which appear to be suitable for bats to roost within or gain access, including slate verges, raised lead-work close to chimneys and gaps under fascia boards. It is recommended that if works are planned for this building emergence surveys when bats are active (May – August) are undertaken to confirm presence /absence by roosting bats.

Although no current evidence of roosting bats was found within these buildings it cannot be assumed that bats are not present when works proposed commence. Care should, therefore, be taken during the work as bats

could roost unseen deep within crevices in the structures. If any bats are discovered during the work, they must not be handled: works must stop immediately, and advice sought from CEC (tel 01872 245510).

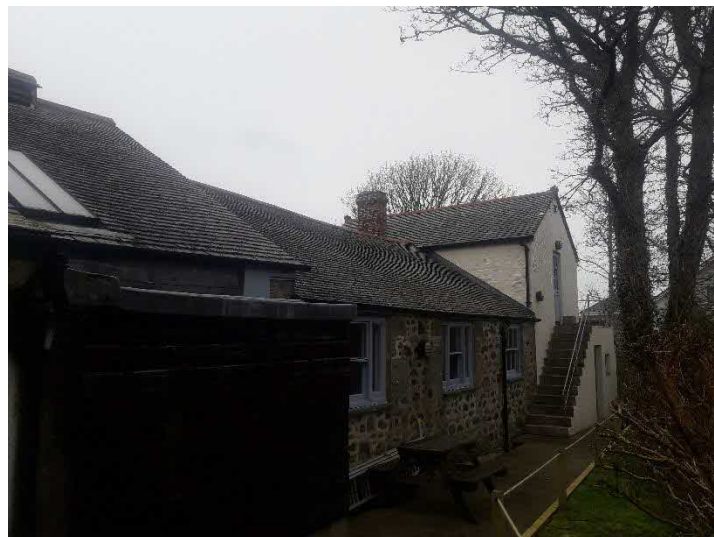
Figure 6. Museum and studio

There are currently no works proposed for these buildings. The museum and studio are two storied buildings which are built from local stones and have slate roofs. The roof of the museum is wet laid with lime mortar and the studio roof is unlined. The studio has a roof void which is insulated using a 'blown' fibre material, the void was entered and searched for use by bats. The exterior of the building was then assessed and it was noted that there are several areas bats could use to roost within. It is recommended that if works are planned for the studio building, emergence surveys when bats are active (May – August) are undertaken to confirm presence /absence by roosting bats.

The upper floor of the museum is in regular use for storage and has an open roof which allowed the underside of the roof to be viewed. The interior is regularly swept as it is a public area, but a search of this area for evidence of use by bats including the floor, stored items, underside of the roof was undertaken. Several bat droppings were noted on stored items close to a wall and appear to have fallen from gaps within roof ridge tiles above.

If the proposal affects the existing roof of the museum, a Bat Mitigation Licence (A13) or Bat Mitigation Class Licence (BMCL) may need to be in place before works commence. To determine the impacts, two emergence surveys between May- September with at least one of the emergence surveys to be completed May-August will be required.
