BAT AND BARN OWL ASSESSMENT

LEACH POTTERY

HIGHER STENNACK

ST. IVES

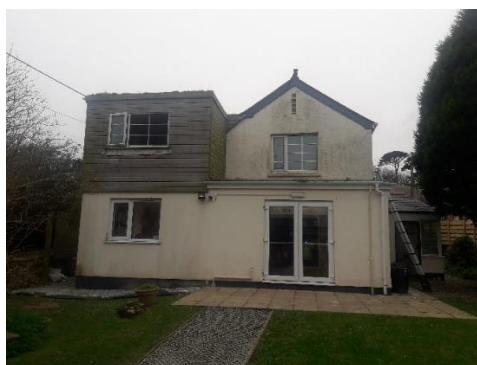
Figure 1. Cottage.

The cottage, which is proposed to be demolished is currently in use as an office and accommodation. This building is two storied and constructed from local stone with cavity walled block-built extensions on the western and eastern elevations and a timber framed extension on the southern elevation. The roof of the building is covered with slate which is underlined with a breathable membrane. There are slates verges on the western and eastern gables of the building. The roof void of this building was entered and searched for evidence of use by bats followed by a search of the exterior. A telescopic ladder was used to gain access to the slate verges and to view any gaps or crevices within the building. No evidence of use by bats was noted.

Although no current evidence of roosting bats was found it cannot be assumed that bats are not present when works commence. Care should, therefore, be taken during the work as bats could roost unseen deep within crevices in the structures. If any bats are discovered during the work, they must not be handled: works must stop immediately, and advice sought from CEC (tel 01872 245510).

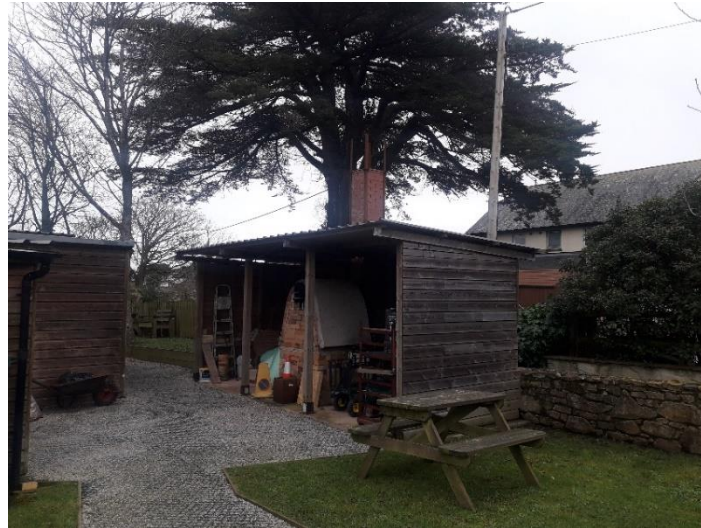
Figure 2. Open fronted store/kiln

This is a wooden built structure which is in use as a store and has a centrally located pottery kiln. The wall of the building is constructed from timber and the roof is covered with corrugated metal sheeting. The building offers limited opportunities for day roosting bats but does offer potential as a night/feeding roost. A careful search was undertaken, including the floor, stored items and viewing the gaps between the bricks used to form the kiln. No evidence of use by bats was noted.

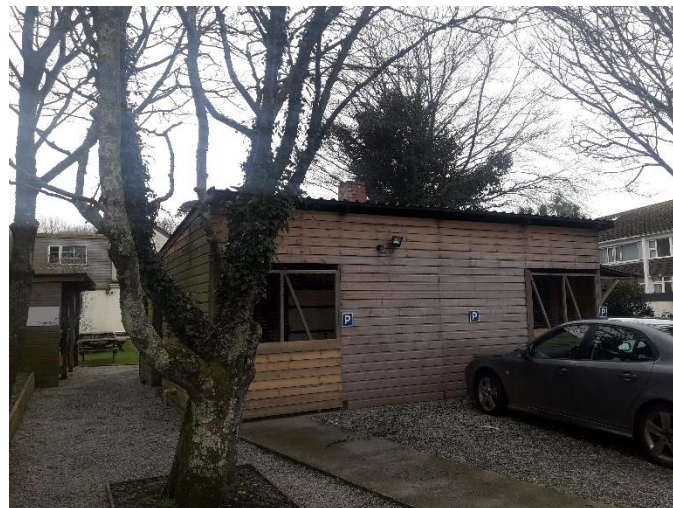
Figure 3. Kiln room and store

This is a single storied wooden structure which is covered with part corrugated metal sheeting and fibre glass. The building is in use for kilns and as storage, as such it is in regular, daily use. Apart from the storage area of the building, the interior is open and light and offers low potential for use by day roosting bats but there are areas open and accessible to night/feeding bats. A search of the interior and exterior was undertaken, including the floors, walls and features considered suitable for use by bats. No evidence of use was noted.

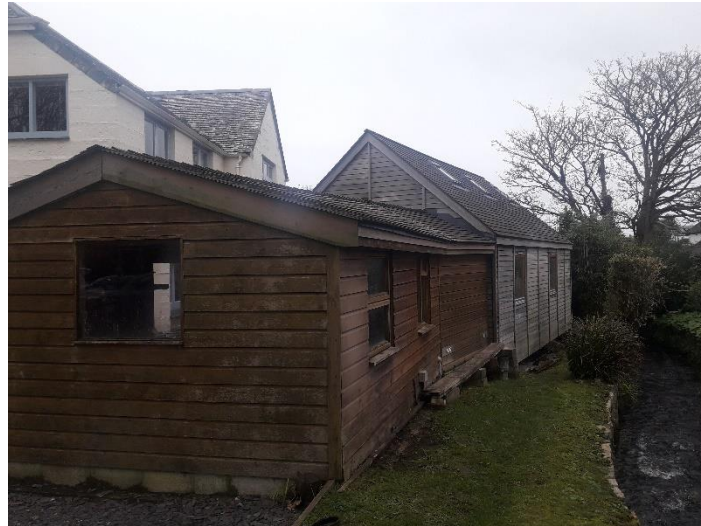
Figure 4. Pottery, Store and part museum

This building is single storied and is clad with timber and has a cedar shingle roof. The building is in use as a pottery, store and part of the museum. As such the interior of the building is in regular, daily use and offers low potential for use by day roosting bats. This assessment concentrated on external features bats could use to roost within and as there are no roof voids, gain access into gaps beneath the shingle roof. The building is tightly sealed with no visible access suitable for use by roosting bats.

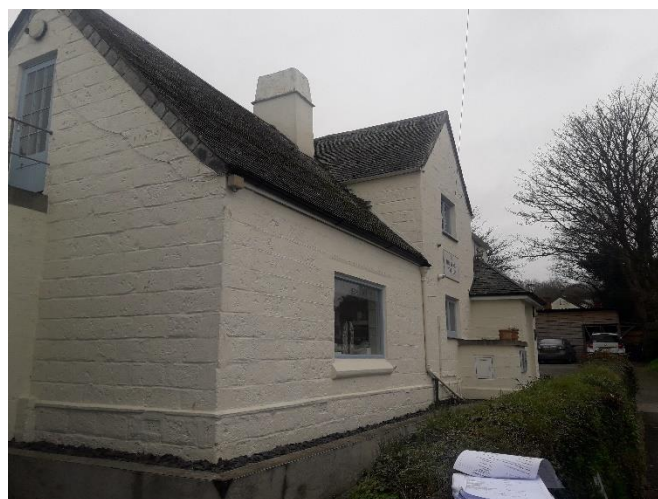
Figure 5. Shop and offices

This is a two storied building built from local stone and cavity walled concrete block with a slate roof. No works are currently proposed to be undertaken on this building and as the building is in regular use, a brief inspection of exterior features offering potential for use by bats was undertaken. The roof of the building has many areas and features which appear to be suitable for bats to roost within or gain access, including slate verges, raised lead-work close to chimneys and gaps under fascia boards. It is recommended that if works are planned for this building emergence surveys when bats are active (May – August) are undertaken to confirm presence /absence by roosting bats.

Although no current evidence of roosting bats was found within these buildings it cannot be assumed that bats are not present when works proposed commence. Care should, therefore, be taken during the work as bats

could roost unseen deep within crevices in the structures. If any bats are discovered during the work, they must not be handled: works must stop immediately, and advice sought from CEC (tel 01872 245510).

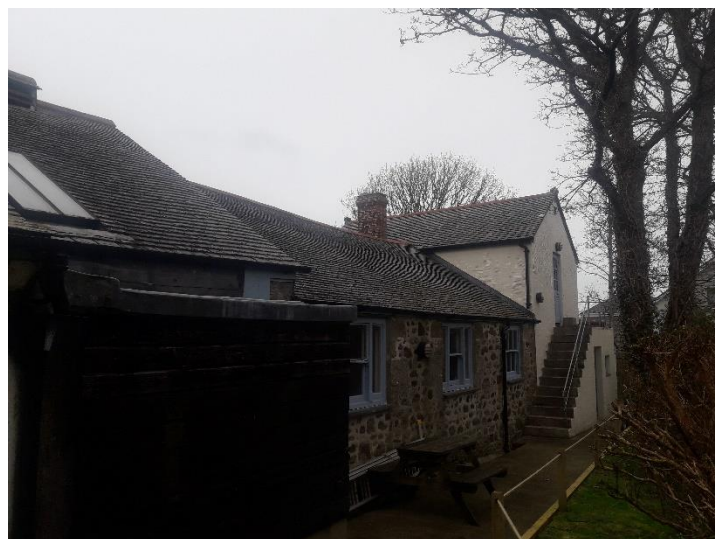
Figure 6. Museum and studio

There are currently no works proposed for these buildings. The museum and studio are two storied buildings which are built from local stones and have slate roofs. The roof of the museum is wet laid with lime mortar and the studio roof is unlined. The studio has a roof void which is insulated using a 'blown' fibre material, the void was entered and searched for use by bats. The exterior of the building was then assessed and it was noted that there are several areas bats could use to roost within. It is recommended that if works are planned for the studio building, emergence surveys when bats are active (May – August) are undertaken to confirm presence /absence by roosting bats.

The upper floor of the museum is in regular use for storage and has an open roof which allowed the underside of the roof to be viewed. The interior is regularly swept as it is a public area, but a search of this area for evidence of use by bats including the floor, stored items, underside of the roof was undertaken. Several bat droppings were noted on stored items close to a wall and appear to have fallen from gaps within roof ridge tiles above.

If the proposal affects the existing roof of the museum, a Bat Mitigation Licence (A13) or Bat Mitigation Class Licence (BMCL) may need to be in place before works commence. To determine the impacts, two emergence surveys between May- September with at least one of the emergence surveys to be completed May-August will be required.
