Leach Pottery St. Ives

Heritage and Repair Statement

Phase 2 Planning and Listed
Building Consent Application

September 2023

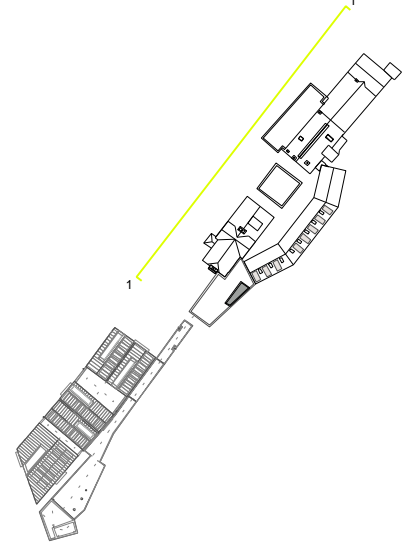
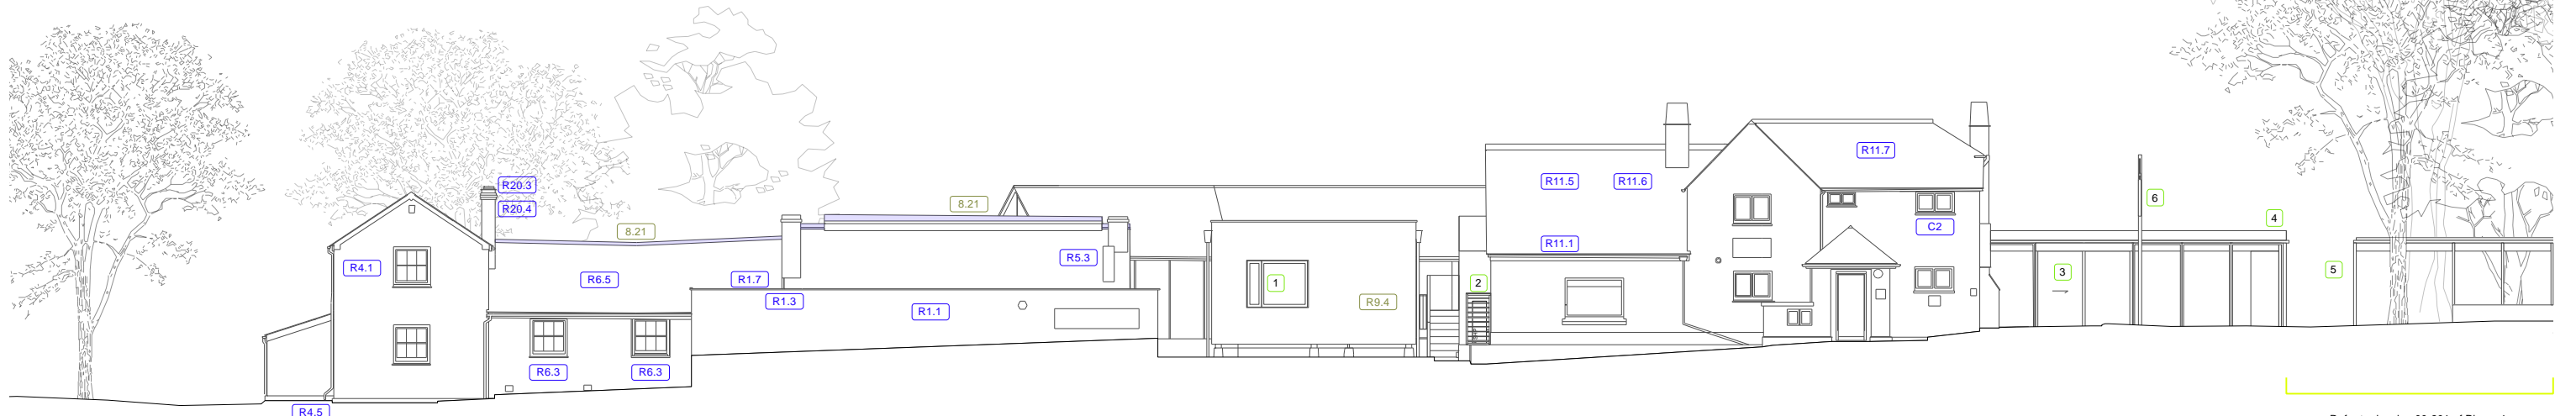
01 Museum & Pottery Cottage - Proposed West Elevation
Scale: 1:100

1. New aluminium framed window, with an openable vent panel
2. Proposed location of new ASHP with louvered timber cover
3. New cafe and entrance structure, timber with glazing to courtyard
4. Zinc flashing to parapet
5. New timber colonnade, connection to education and production building (drawing 00-201)
6. New hanging swing sign

For full details of repair works, refer to the DJA repair schedule

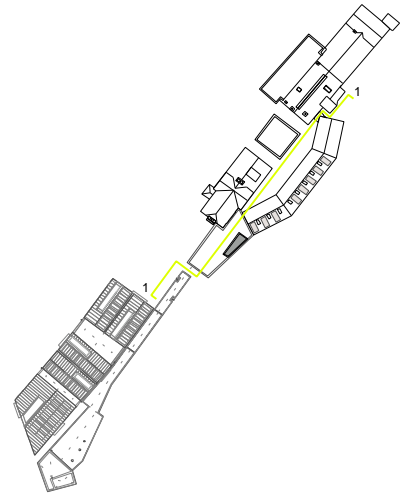
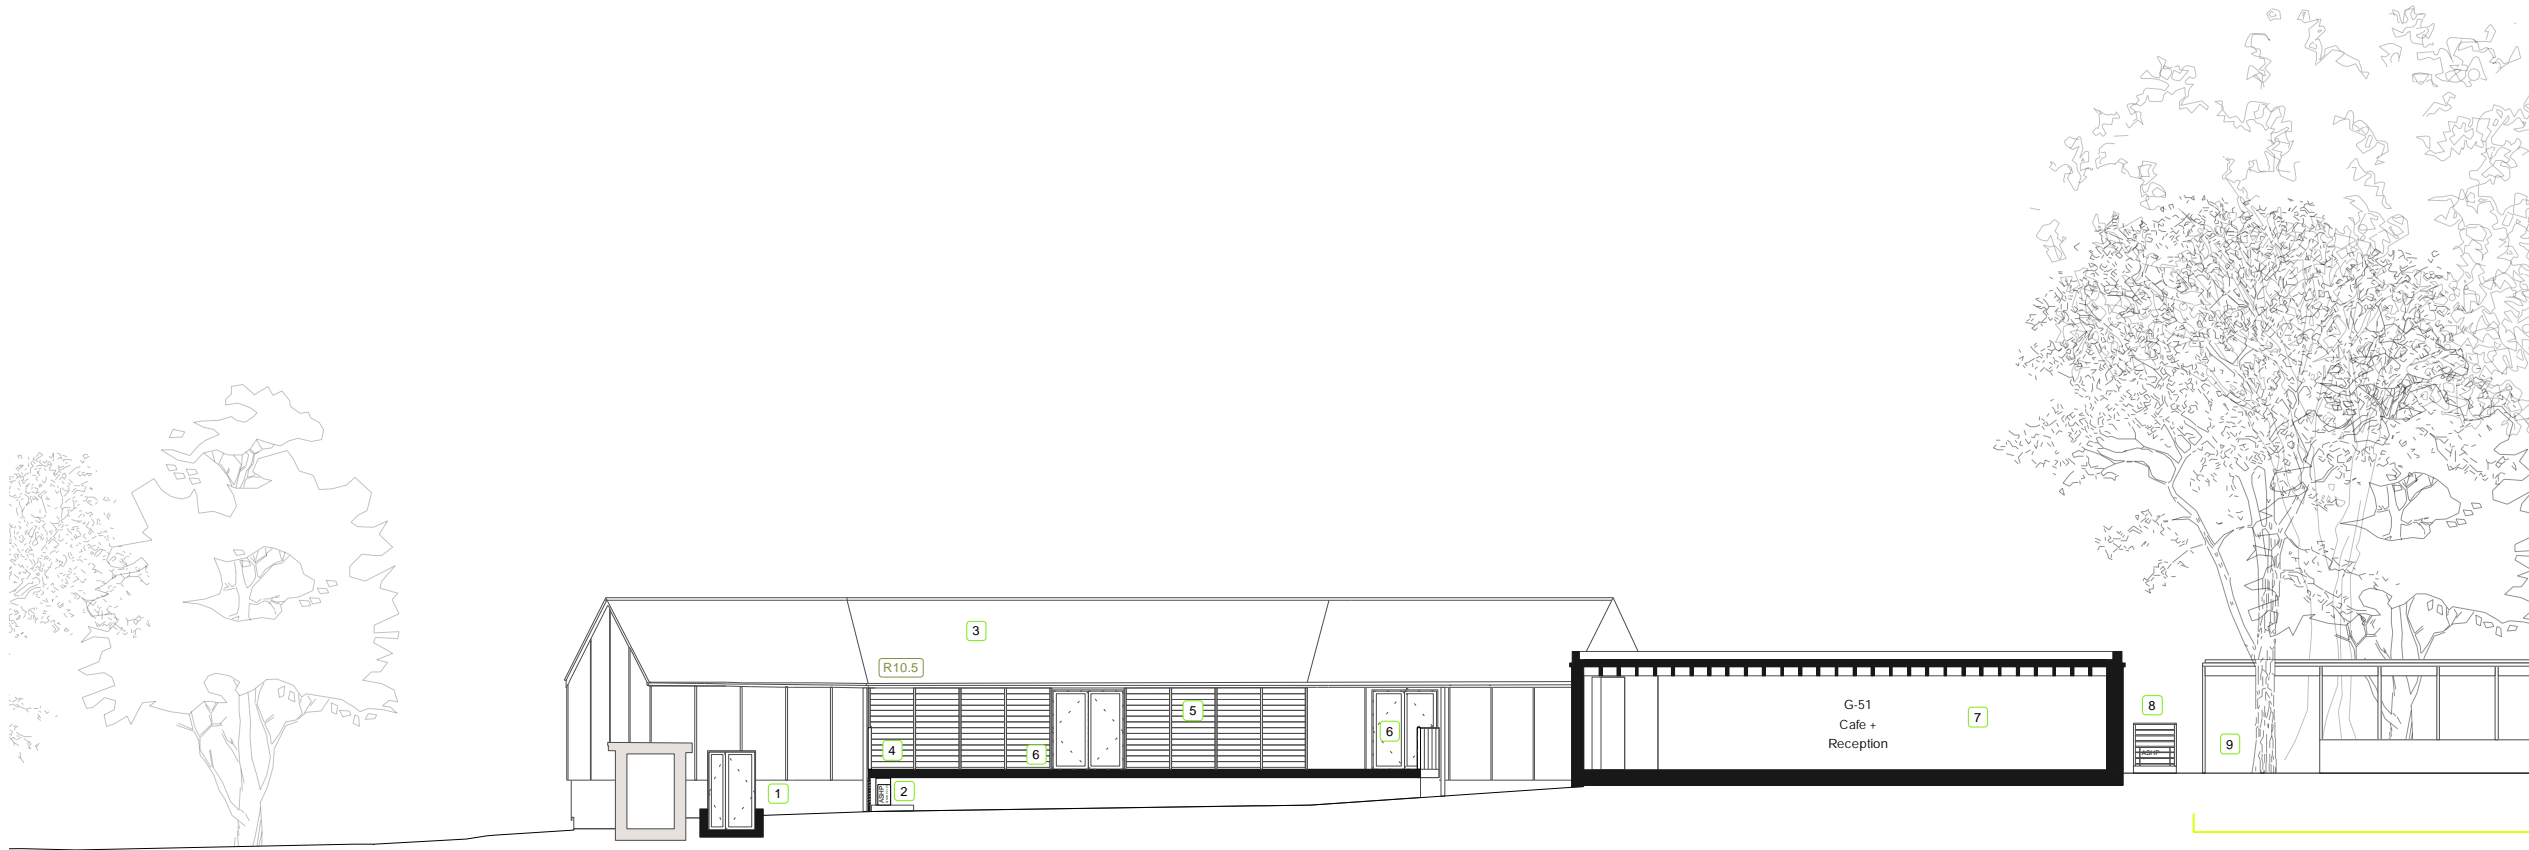
01 Gallery Building - Proposed West Elevation
Scale: 1:100

1. New aluminium framed glazed door, painted and access ramp
2. Proposed location of new ASHP's with louvered timber cover
3. Existing roof retained
4. New expanded area of timber decking, with stainless steel balustrading to edges
5. Western red cedar cladding to match existing, untreated
6. New aluminium framed glazed door, painted
7. New cafe and entrance building
8. Proposed location of new ASHP and existing gas intake with louvered timber cover
9. New timber colonnade, connection to education and production building (drawing 00-201)

[R10.5] Replace all rainwater goods with a new zinc rainwater system from VM Zinc.

For full details of repair works, refer to the DJA repair schedule

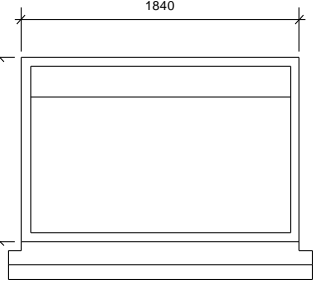
<p>Internal Photo Reference</p>
<p>Window reference: W.55 Room: G-57 Shop Approximate age of fabric and reason: Possibly original 1920's. Prominent Ovolo type profile to mullion, however the profile of the sill differs. Opening: One fixed pane and one side-hung outward opening pane</p>	<p>Description of current condition: Window is in need of general refurbishment. Proposed works: Window to be refurbished and redecorated. Ironmongery retained.</p>	<p>Window reference: W.56 Room: G-57 Shop Approximate age of fabric: Possibly original 1920's. Prominent Ovolo type profile to frame and mullion Opening: One fixed pane and one side-hung outward opening pane</p>	<p>Description of current condition: Window is in need of general refurbishment. Proposed works: Window to be refurbished and redecorated. Ironmongery retained.</p>	<p>Window reference: W.57 Room: G-57 Shop Approximate age of fabric: A recent commercial replacement. Historic photograph, dated 1931-1937, shows a single pane window. A later photograph, approximately dated from the 1960's shows a three fixed pane pattern. Opening: Single glazed fixed window</p>	<p>Description of current condition: Window is in need of replacing. Proposed works: Investigate the condition of the window lintel in preparation for the works involved in replacing the window with a hardwood timber frame and double glazing.</p>
